**Watchic Lake
Association**

WATER QUALITY RISK ASSESSMENT

FINAL REPORT
MARCH 2016

APPENDIX A – 2015 WATERSHED SURVEY

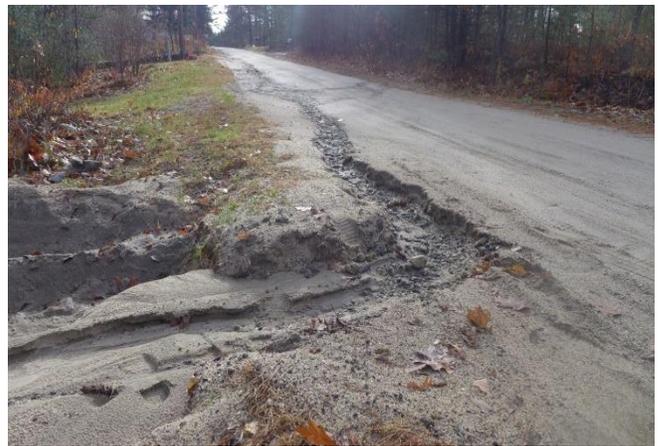
This site is located approximately halfway down Hi Vu Drive and is a low point in the road where rills and gullies are forming along the road shoulder. It runs parallel to the northwest corner of the lake with only about 200 feet of buffer between the road and the lake. This buffer is comprised of mixed forest as well as significant residential development. At this site, runoff appears to be flowing along the ditch on the west side of the road and then crossing the road through a buried culvert. The “outlet” of the culvert is filled with sediment and is not visible. This outlet is also receiving sediment from a large gully that runs along the eastern side of the road (see Photo 1). The water then continues as surface flow through the woods and down to the lake. Correspondence with a nearby landowner suggests that this strip of land is owned by the Kiwanis Club and is used as a right-of-way for local residents to access the shoreline. The gully along the road at this site is approximately 100 feet long by 1 feet wide by 0.5 feet deep. Using the USEPA Region 5 Pollutant Load Reduction Model, this gully may be contributing 0.7 tons of sediment/year and 0.6 lbs. of total phosphorous (TP) per year to the lake. FBE recommends multiple best management practices (BMPs) at this site, including re-crowning the road to control runoff and enlarging the culvert at the crossing. While it would be ideal to install a settling basin on the west side of the road, this land is private, and therefore it is recommended that a settling basin be created instead on the east side of the road below the outlet of the culvert. This settling basin would need to be large enough to accommodate the high flows that are evidently causing this severe erosion. Furthermore, it would be beneficial to armor and vegetate the area further down on the shoreline access road. This site has been remediated in a past grant project, but no longer seems to be functioning well. Because of this, it may be best to consider paving.

PHOTO 1. Gully formation along Hi Vu Drive

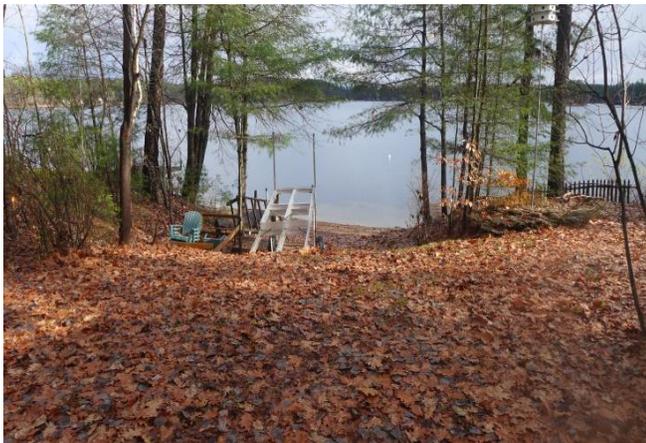
Moderate surface erosion was evident along the road leading to the boat access at the Kiwanis Club (Photos 2, 3). This road runs directly perpendicular to the beach, allowing road runoff to enter the lake without treatment. Additionally, rill and gully formation along this road and beach access can be safety hazards for recreational users of

PHOTO 2. Shoreline access point below Hi Vu Road erosion.

the area. Due to the high traffic in this area and its proximity to the lake, this site has been identified as a high priority site. It is our recommendation that runoff diverters be installed at multiple areas along the road above the recreation area to divert runoff water to the forest.

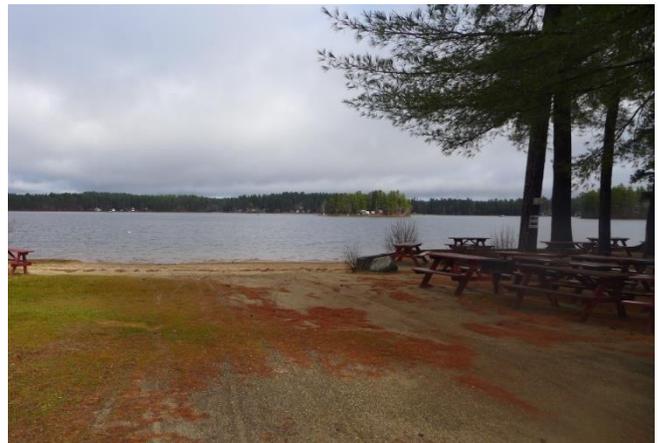
PHOTO 3. View of Watchic Lake from the Kiwanis Club access road.

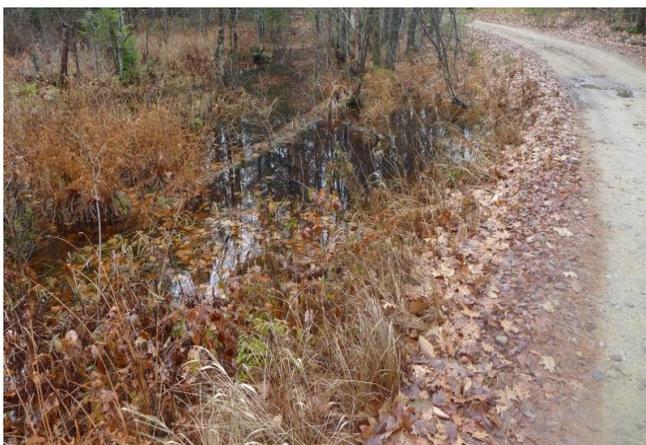
Site 3 was located on Watchic Road 21 at the crossing of a small tributary to Page Brook (Photos 4, 5). This site is noted as low impact because of only minor evidence of erosion; however, some rills in the gravel were present above the stream crossing. High flows were also evident, indicating that nutrients from sediment erosion in this area can easily be transported to the lake. Using the Region 5 model for estimating total phosphorous (TP) inputs, it is estimated that this site contributes 0.2 tons/year of sediment and 0.2 lbs./year of TP to the lake. We recommend widening and vegetating the road shoulder at this crossing to intercept runoff to the stream. Alternatively, it is possible to armor the road shoulder and culvert with geotextile fabric and stone.

PHOTO 4. A view of the stream crossing on Watchic Road 21.

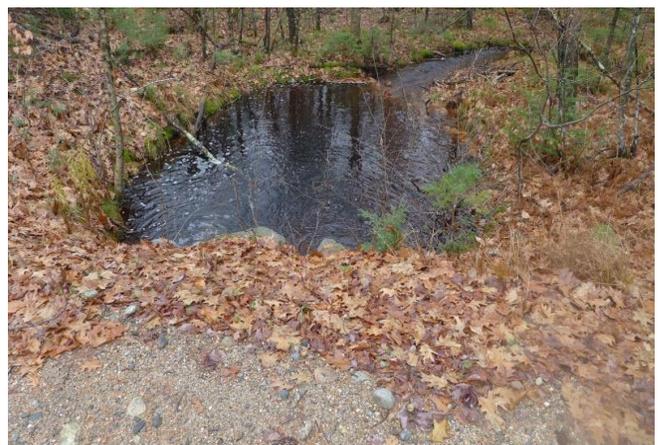
PHOTO 5. Road shoulder erosion on Watchic Road 21.

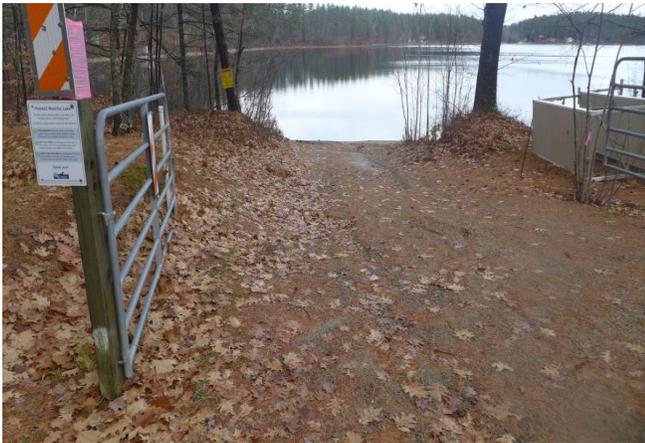
Site 4 is an area of high concern due to the steepness of the hill leading directly to the boat launch at the terminus of Hi Vu Drive (Photo 6). The west side of Hi Vu Road has significant ditch erosion that eventually flows to an old turnout off the road and into the woods (Photo 7). Hydrologic markers indicate that this turnout is not at the proper capacity to successfully handle large flows during rain events. We recommend that both the ditch and culvert be enlarged to accommodate greater flow volumes. Additionally, we recommend the installation of a runoff diverter above the boat launch to divert sheet flow from the road to the neighboring woods.

PHOTO 6. View of the boat access at the terminus of Hi Vu Drive

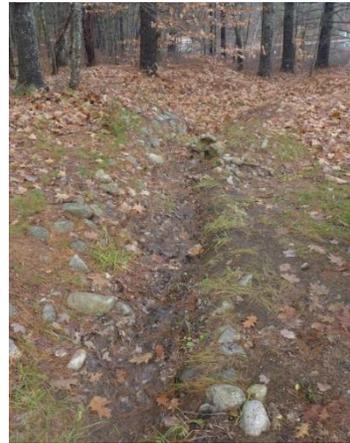
PHOTO 7. Trench along the west side of the boat access diverting water to a settling basin.

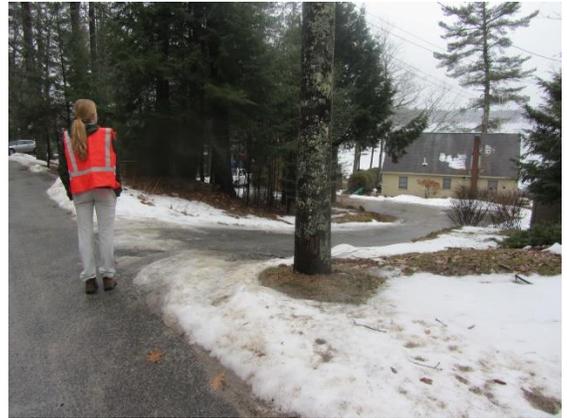
Watchic Terrace Road is a short (~0.1 mile) road located off Route 113 on the northeast side of Watchic Lake. The road cuts across a steep embankment rolling towards the lake and has private residential units situated on both sides. The residential homes along the lake are close to the water with steep driveways acting as conduits for stormwater runoff (photo 9). Furthermore, significant stormwater runoff flows along the northeast (uphill) side of the road, causing visible sediment mobilization. A six-inch-high berm of pavement along the uphill side of the road directs runoff to the paved road shoulder. Three catch basins along this side of the road capture this runoff and direct it to a cross-drainage culvert at the end of the road. This culvert discharges the runoff into riprap (photo 10) along the driveway of house #29. Below the riprap is a large ponding area on a lawn located within proximity of Watchic Lake.

PHOTO 9. An example of a steep driveway on Watchic Terrace Road leading into Watchic Lake.

Because of the steep slopes and private property access, recommendations are limited; however, there are several best management practice (BMPs) options to help improve stormwater management. We suggest installing catch basin filters in each of the three catch basins to help remove sediment. Creating a turnout for stormwater to divert some runoff to vegetated areas for infiltration may be possible in one roadside location near house #15. Lastly, adding infiltration steps or a large bioretention cell below the riprap at the end of the road would infiltrate the water, slow down its path to the lake, and limit ponding in the lawn area. Landowner cooperation would be required to implement these BMPs due to the lack of open space between the road and private land.

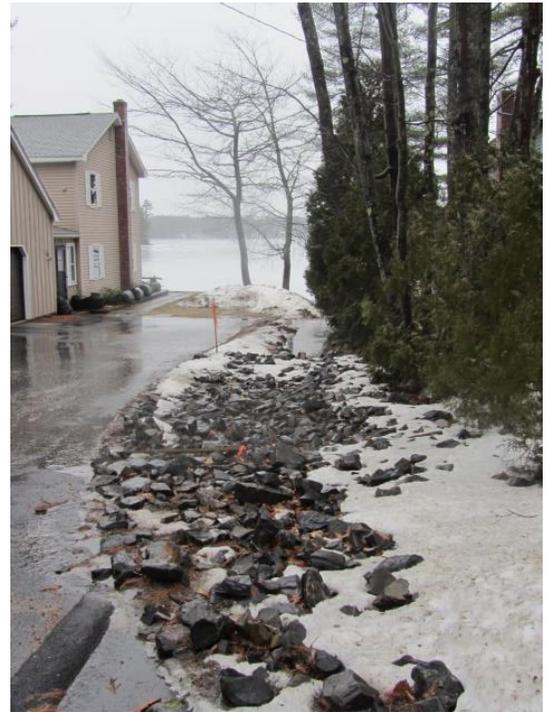
PHOTO 10. Riprap along house #29 at end of Watchic Terrace Road.
