**Watchic Pond Watershed
Nonpoint Source Pollution Survey Project**

Cumberland County Soil and Water Conservation District

Maine State Department of Environmental Protection

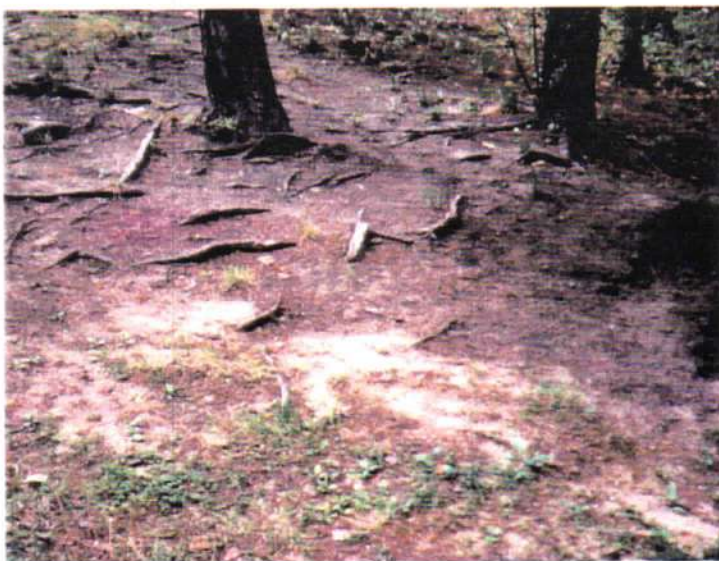
Exposed roots are the result of:

- *erosion and soil compaction from uncontrolled foot traffic and water flow (from roofs and upland areas)*

The solution is to:

- *limit foot traffic to a defined pathway*
- *slow water flow (by directing it towards vegetation)*
- *apply bark mulch to protect the roots from further deterioration*

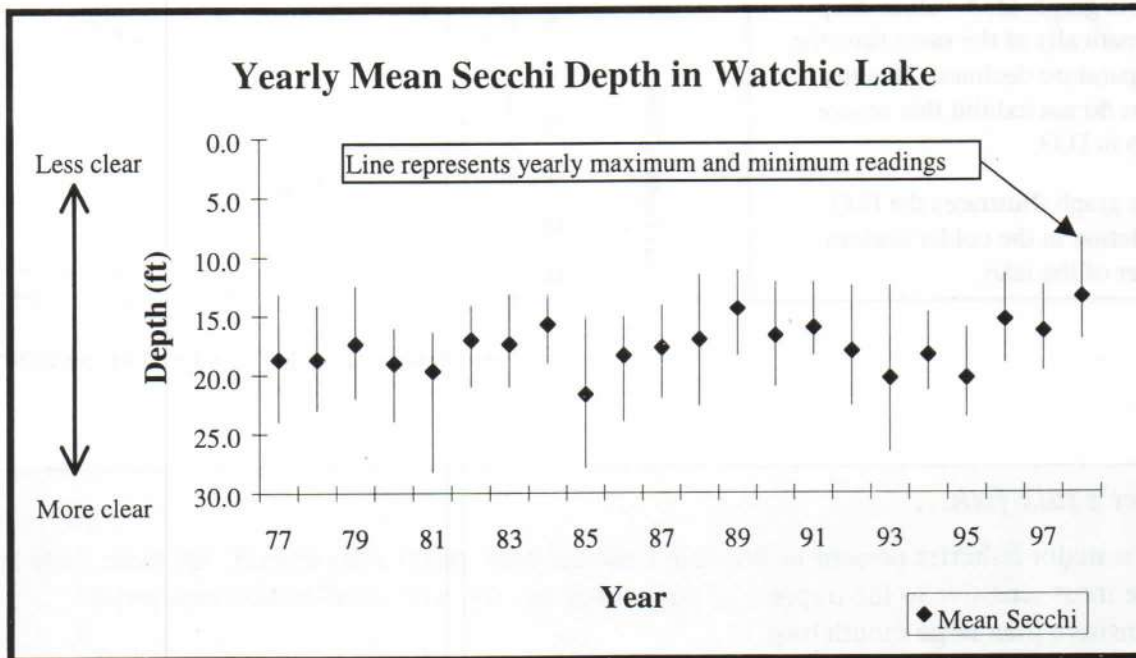
- ◆ The variability in secchi disk yearly data has been exacerbated by the normal fluctuations in weather (i.e., '97: very dry, '98: very wet). This variability makes it hard to determine a trend from secchi data.
- ◆ MDEP biologists suggest that dissolved oxygen values paint a much better picture of the decline in water quality.

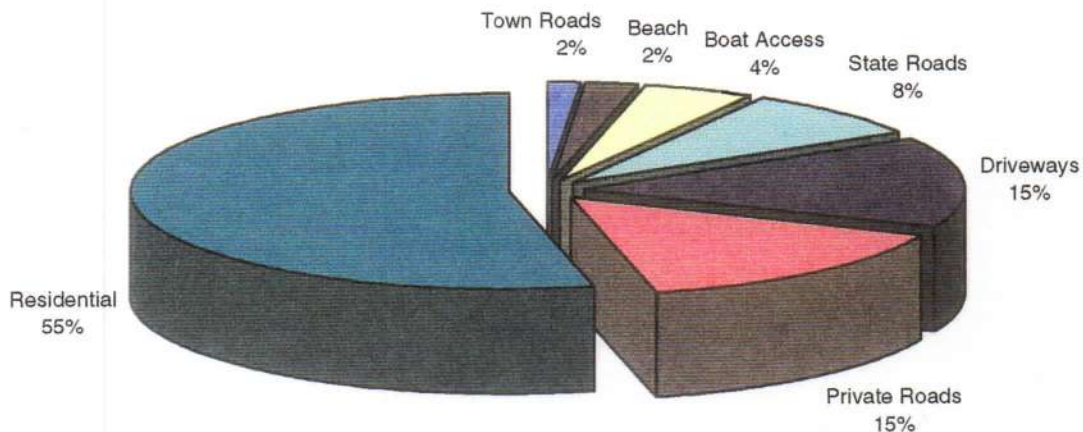
Percentage of Sites by Land Use

Volunteers and technical staff identified 135 sites that may be having an impact on the water quality of Watchic Lake.

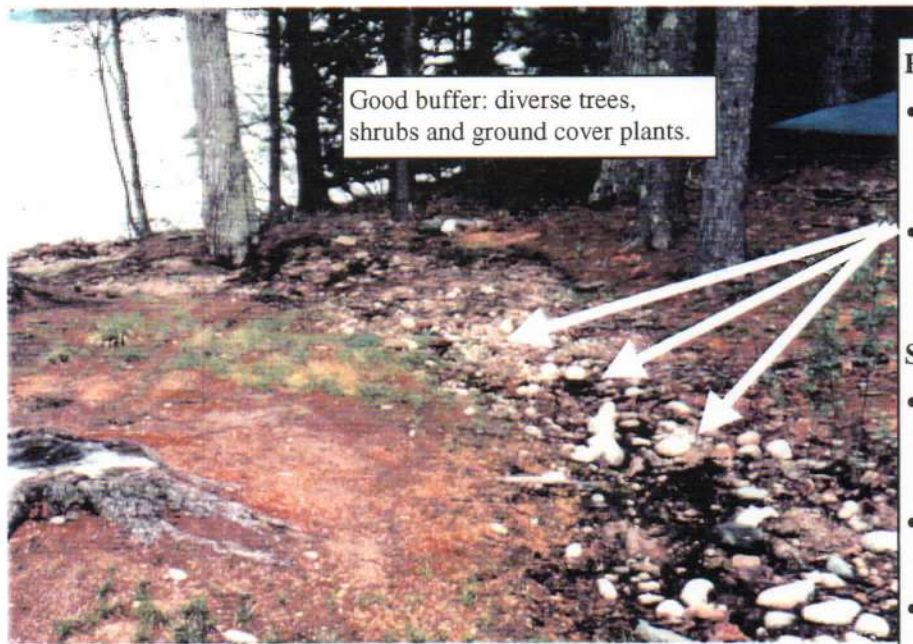
Problem:

- arrows point to land that has eroded down to rock and sand
- area closest to the lake needs more trees, shrubs and ground cover plants

Solution:

- direct stormwater into the established area of trees (to the right)
- seed and mulch the eroded strip
- a diverse mix of trees, shrubs and ground cover plants will stabilize this area better than grass

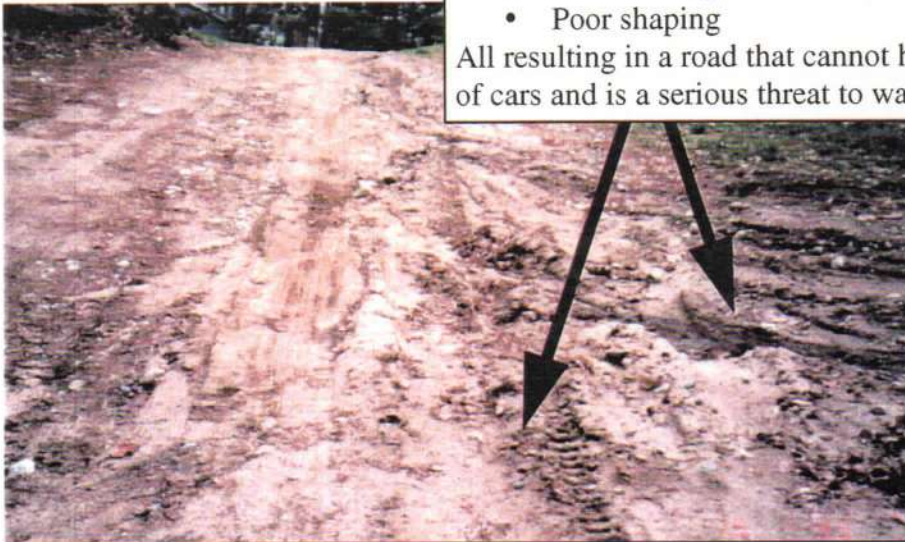
Problem:

- Poor surface material
- Poor drainage from road
- Poor shaping

All resulting in a road that cannot handle the impact of cars and is a serious threat to water quality.

Solution:

- apply less erodable surface material
- install turnouts to direct water off road into vegetated buffer areas
- reshape road surface

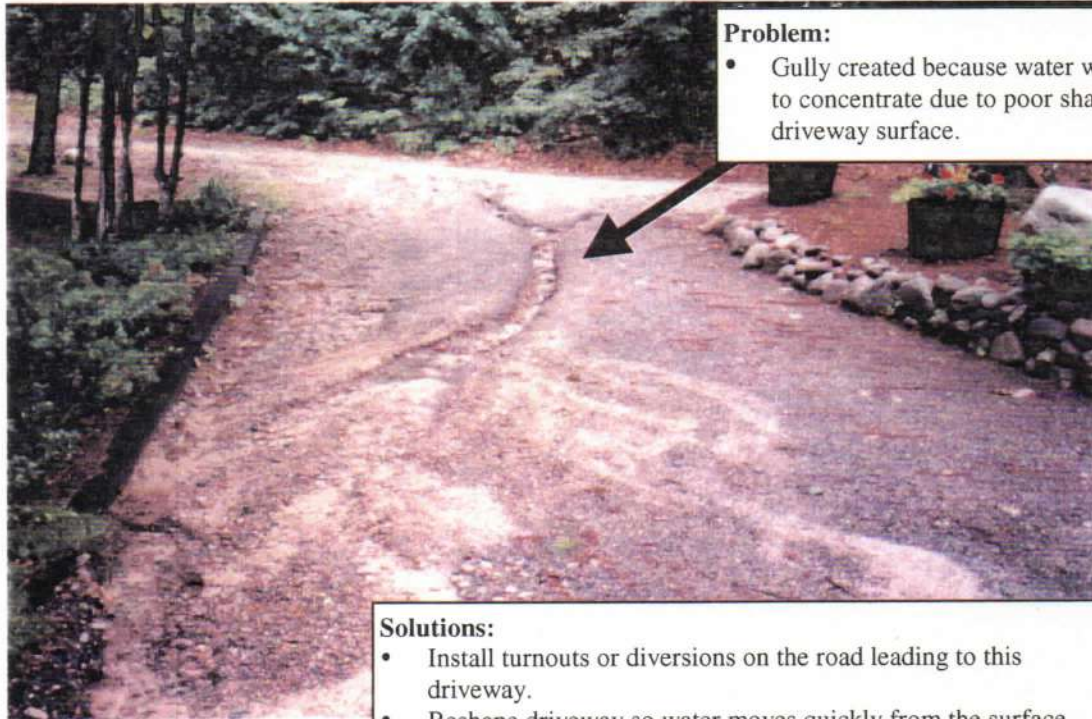
Problem:

- Gully created because water was able to concentrate due to poor shape of driveway surface.

Solutions:

- Install turnouts or diversions on the road leading to this driveway.
- Reshape driveway so water moves quickly from the surface (there should be $\frac{1}{2}$ " of crown for each foot of width).

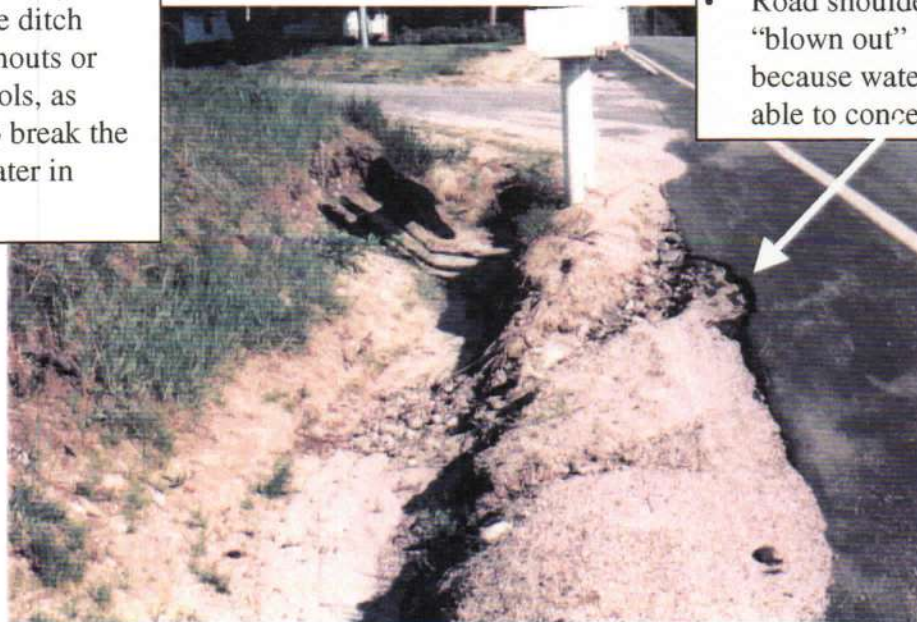
Problem:

- Road shoulder has "blown out" because water was able to concentrate.

Solution:

- remove winter sand
- reditch and vegetate to stabilize ditch
- install turnouts or plunge pools, as needed, to break the flow of water in ditches

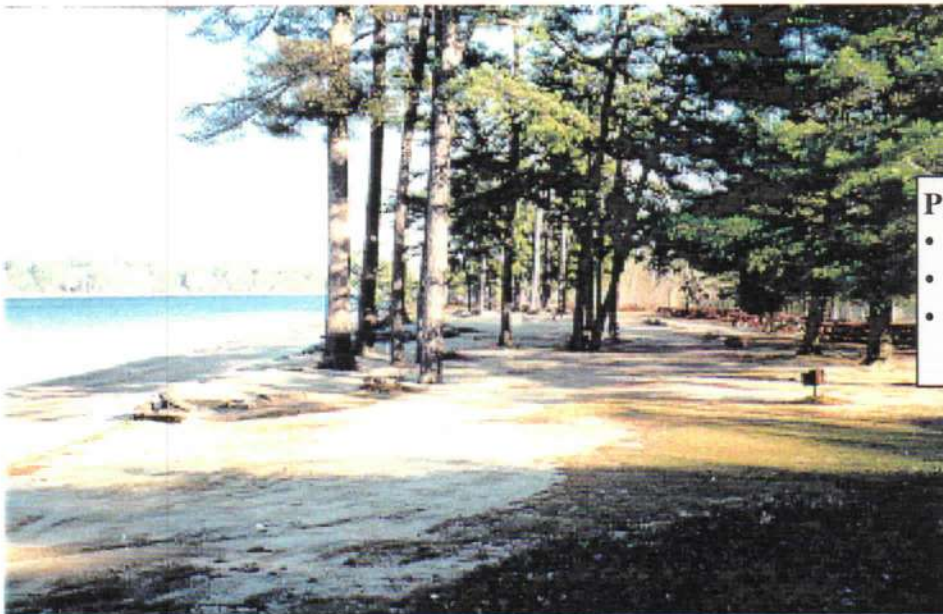
Problem:

- bare soil
- exposed roots
- moderate surface erosion

Solution:

- seed and mulch between trees and picnic tables (high use area needs vegetation to prevent erosion)
- install erosion controls, as needed
- reduce size of beach, if possible
