WATCHIC LAKE

WATERSHED-BASED PROTECTION PLAN

2020-2030

March 2020 - WLA Member Version Including Grant Opportunities

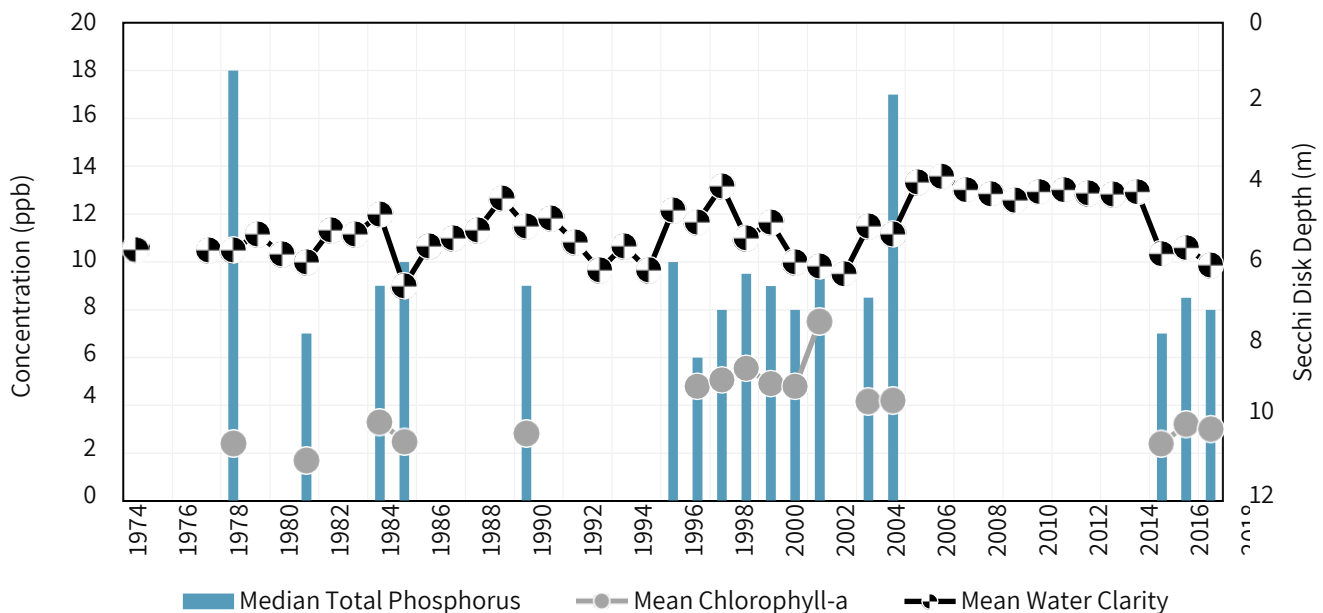
Figure A2. Watchic Lake mean annual water clarity and median annual total phosphorus and chlorophyll-a for epicore samples only. Trend analysis conducted using the non-parametric Mann Kendall test showed no statistically significant trends over time.

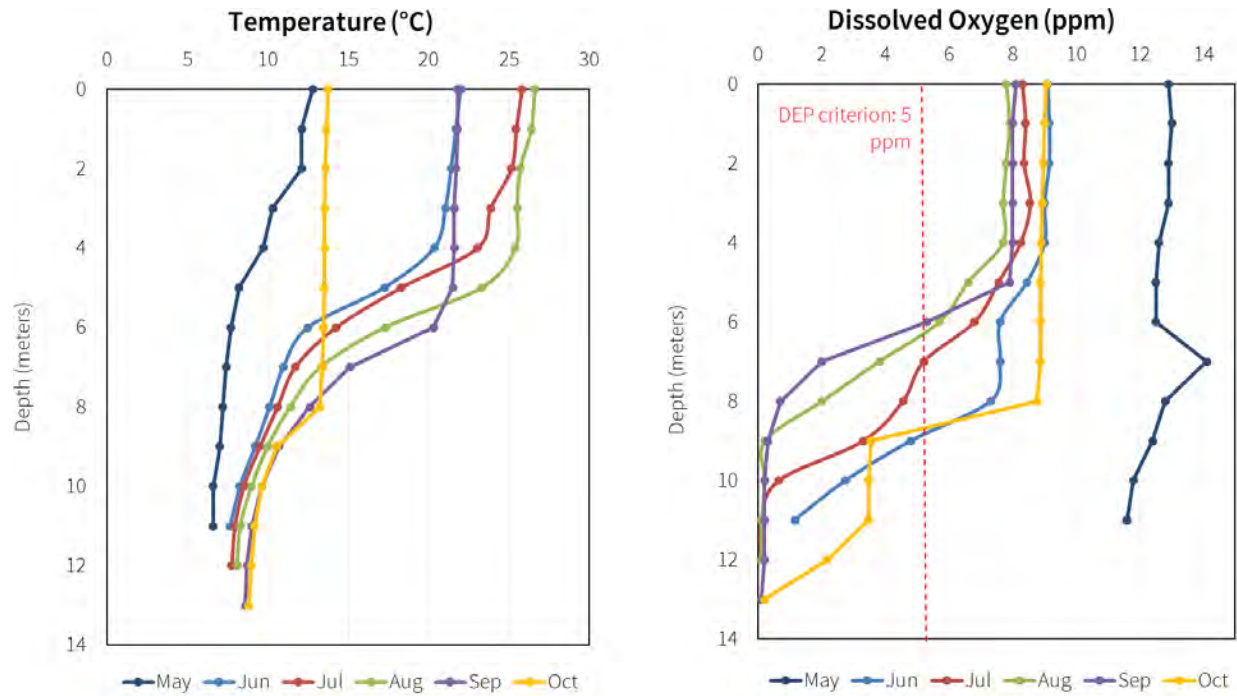
Figure A4. 2018 temperature (left) and dissolved oxygen (right) profiles for the deep spot of Watchic Lake. Displayed profiles represent the average monthly readings at each depth from FBE and WLA volunteers. Dissolved oxygen depletion at the bottom of the lake is evident as early as the June sampling (dropping below 5 ppm at 9 meters). In July - Sept, dissolved oxygen is below 5 ppm around 7 meters.

Figure A4, on the following page, shows an example heat plot of dissolved oxygen (top) and temperature (bottom) from 2018. These plots help to identify the timing of the onset of spring stratification and fall turnover, as well as the extent and duration of low oxygen in the bottom of the lake. Continuous monitoring for the past three years has allowed the WLA to closely track changes to the lake. As this dataset grows, it will give the WLA a better understanding of the influence of human development and climate change on critical lake properties. Complete annual water quality reports for 2016, 2017, and 2018 can be found at the WLA webpage (<https://watchiclake.org/about-watchic-lake/water-quality/>).

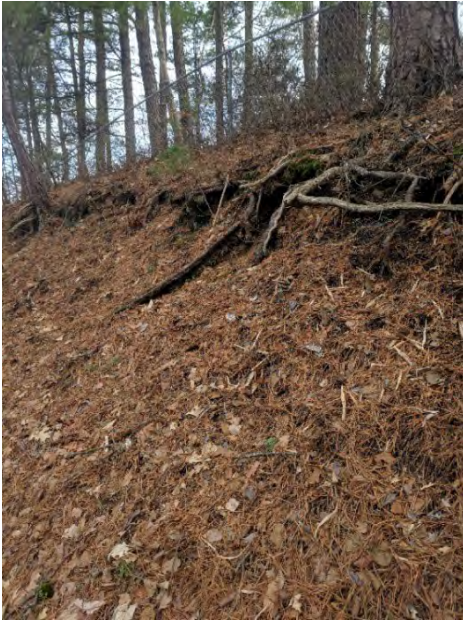
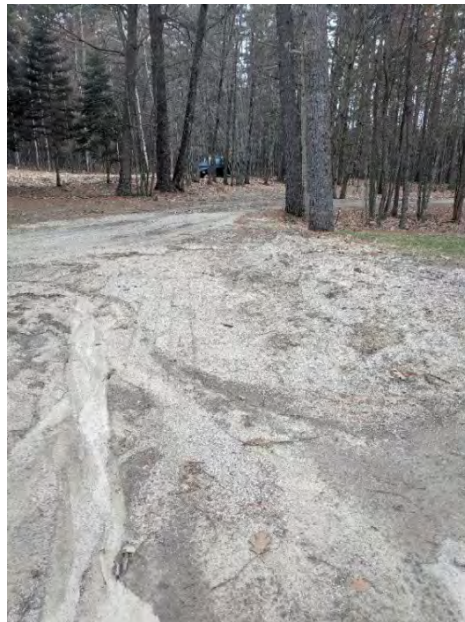
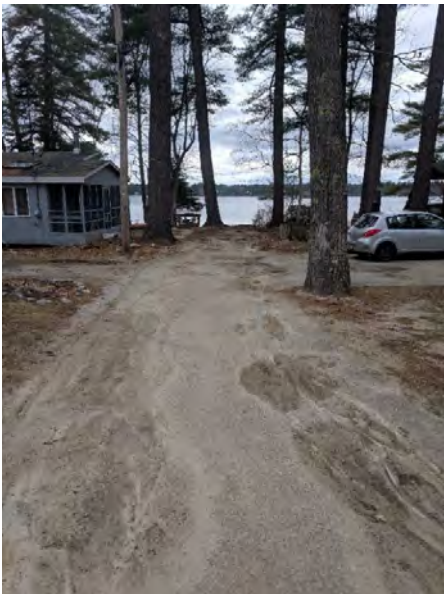
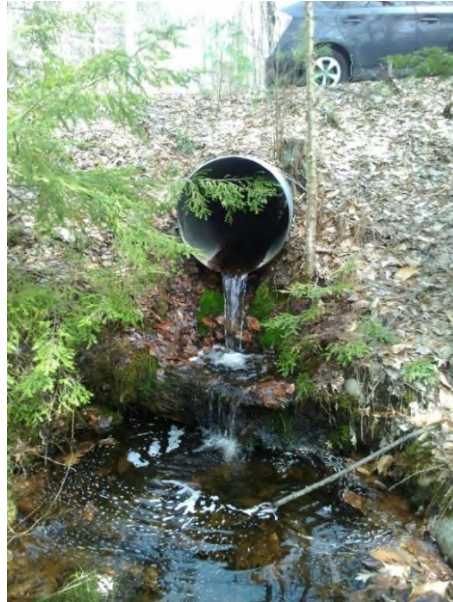
Examples of watershed survey sites (clockwise from top left); bank erosion (A-1), road surface erosion and gully formation (site A-9), hanging culvert (site B-2), and winter sand and sediment transport (A-11).

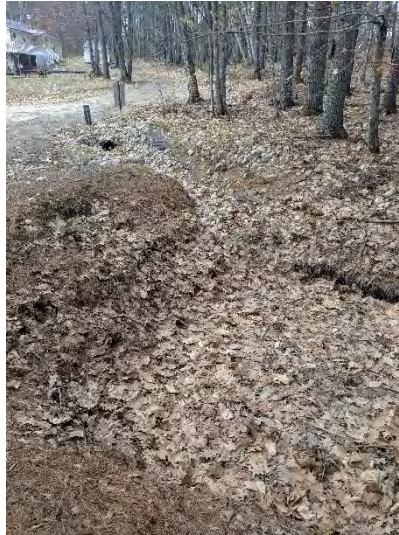
OBSERVATIONS: Road shoulder and ditch erosion is occurring along the end of Hi-Vu Drive. Evidence of large volumes of water draining to this area. The installed stormwater controls (ditch armoring, check dams, and settling basin) are clogged with leaves and sand.

Road shoulder erosion along Hi-Vu Drive and settling basin and ditches clogged with leaves and sand.

RECOMMENDATIONS: Increase frequency of maintenance for the ditch and settling basin by removing leaves and sand. Install a runoff diverter to interrupt and direct flow at the launch to the settling basin.

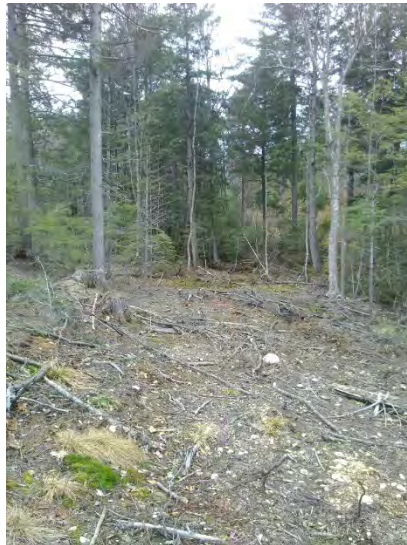
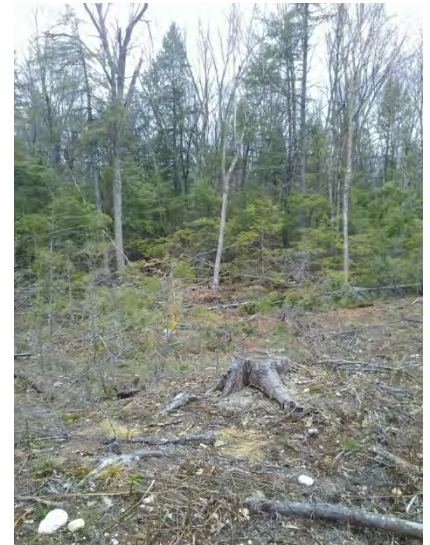
(2) Logging operation adjacent to Page Brook (Site B14)

OBSERVATIONS: Logging operations alongside Page Brook have created an inadequate buffer risking bank destabilization and increased sediment transport into the stream. Decreased buffers also reduce necessary stream shading for aquatic organisms.

Logging directly adjacent to Page Brook.

RECOMMENDATIONS: Maintain buffer during future logging activities and plant new buffer along previously cleared areas. We recommend the WLA communicate with the landowner to create a working relationship moving forward.

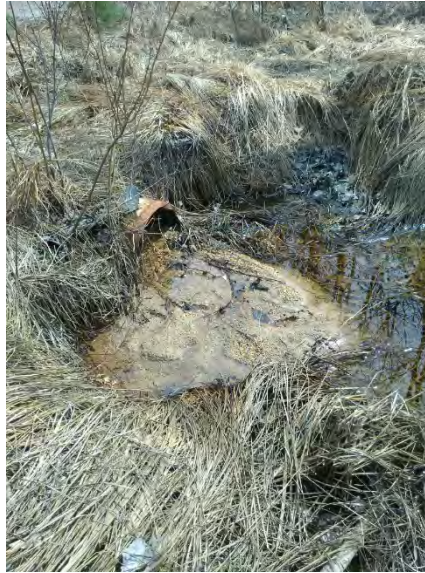
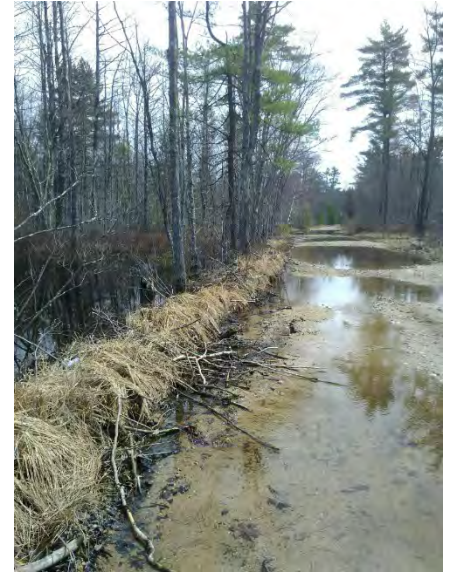
(3) Middle Road and Paine Brook Crossing (Site B4)

OBSERVATIONS: Culverts are undersized, crushed, clogged, or broken. Road surface erosion and sediment transport is evident in areas where water is flowing directly across the road. A beaver dam along the road has caused road flooding. ATV and logging use has destabilized paths and the road.

One of several clogged or broken culverts (left) and the beaver dam adjacent to the road (right).

RECOMMENDATIONS: Consider road closure or rerouting. Replace culverts and stabilize road surface and edge. This project would require detailed engineered design.

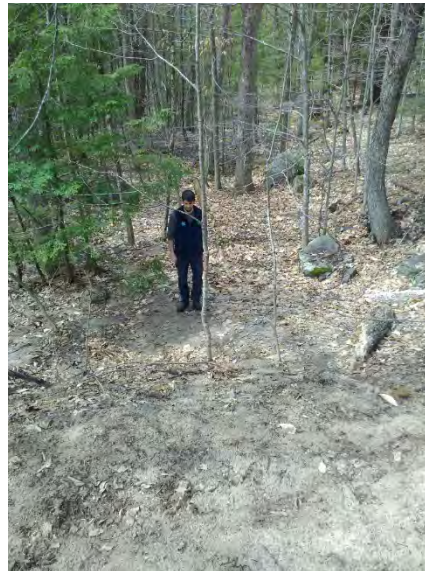
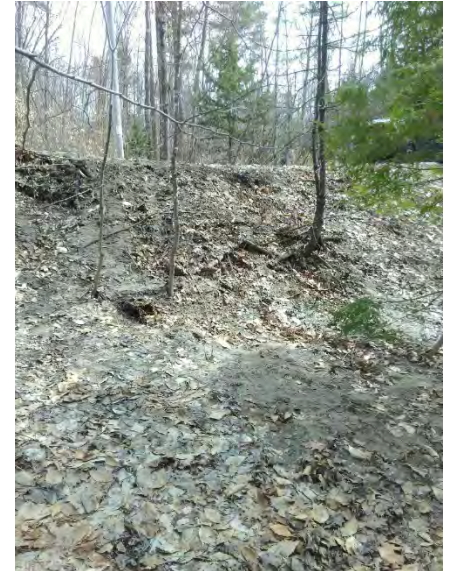
(4) Dolloff Road and Paine Brook Crossing (Site B2 and B3)

OBSERVATIONS: Road shoulder and ditch erosion are evident, allowing winter sand and sediment to wash down the bank and cause further bank erosion, directly adjacent to a Paine Brook tributary culvert.

Sand and sediment washing down the road shoulder, approximately 20 feet from Paine Brook.

RECOMMENDATIONS: Remove grader and plow berms and implement street sweeping practices to prevent winter sand and sediment from accumulating at the low point in the road and washing down the bank into the stream. Vegetate the road shoulder. Enlarge and re-align culvert.

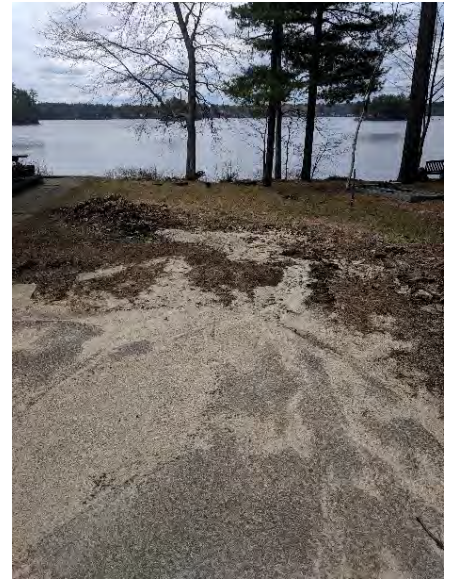
(5) Watchic Terrace Road (Site A10)

OBSERVATIONS: High water volume runoff down Watchic Terrace Road is directed to an undersized filtration system causing severe road surface erosion and clogged riprap and culverts. Evidence of severe runoff (deep gullies) in upslope gravel driveways. Poor maintenance of catch basins along roadway and significant aggradation of winter sand.

Sand and sediment transport down Watchic Terrace Road, and winter sand accumulation at road end.

RECOMMENDATIONS: Work with the road association to outline a maintenance plan for this treatment system, including the catch basins and the settling basin. Consider approaching the Town regarding maintenance of this roadway. If possible, hire an engineer to redesign the stormwater controls in this tight space.

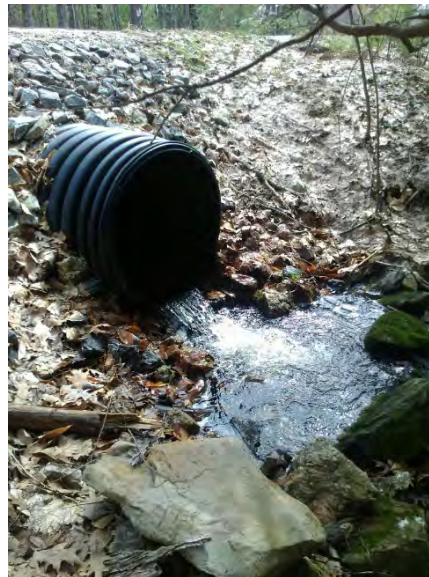
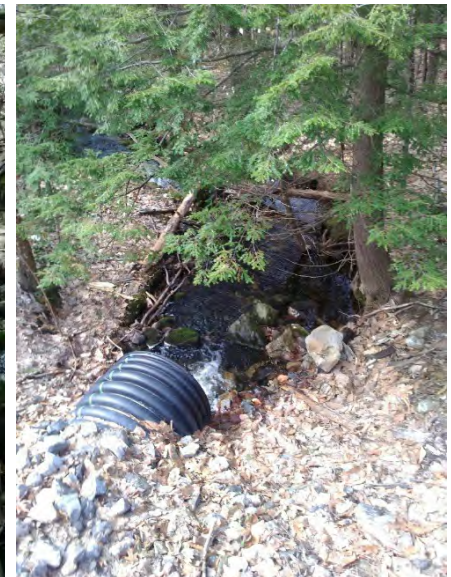
(6) Oak Hill Road Stream Crossing (Site B1)

OBSERVATIONS: This site has a slight perched culvert (approximately six inches).

The perched outlet of the culvert crossing on Oak Hill Road.

RECOMMENDATIONS: Recommendations include enlarging the culvert and creating an armored plunge pool.

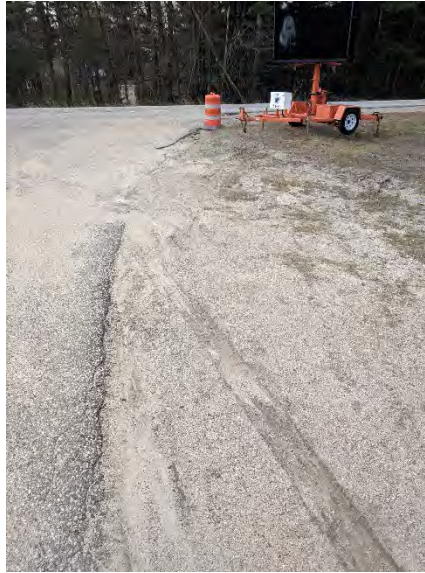
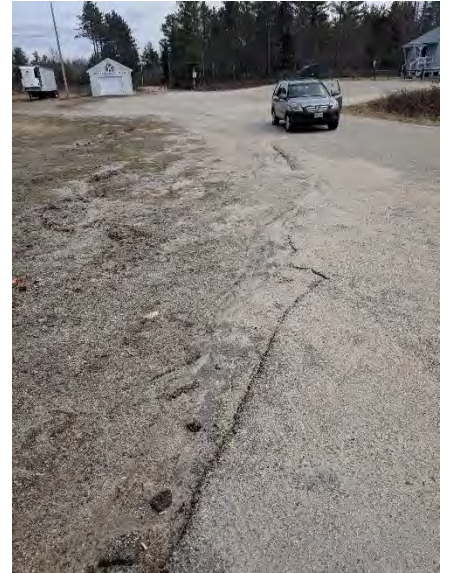
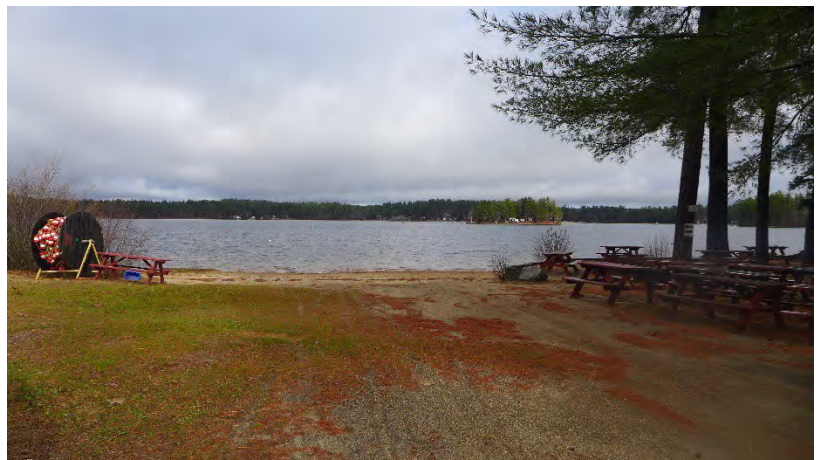
(7) Kiwanis Beach Access Road (Site A4)

OBSERVATIONS: The Kiwanis Beach access road was not surveyed in 2019. However, a survey by WLA and FBE staff occurred in 2015. We have included this site using the 2015 survey results and aerial imagery, as no work is known to have occurred in this four-year period. During the 2019 survey, the entrance to the Kiwanis Beach access road had evidence of significant sediment accumulation. This gravel road leads directly to the beach and may be contributing sediment during runoff events. Additionally, in 2015 FBE noted the public beach area encroaching into the forested area to the southeast, evidenced by numerous trails.

(Top) the entrance of the Kiwanis Beach access road documented during the 2019 survey. (Bottom) the Kiwanis Beach documented during the 2015 survey. The access road runs directly to this section of the beach.

RECOMMENDATIONS: Address sediment accumulation at the beginning of the roadway by encouraging street sweeping, re-establishing the curb and directing stormwater to a settling basin in the grass to the northwest of the road. Minimize sediment runoff down the access road. This could include the installation of waterbars that direct water to infiltration basins or infiltration trenches or updating the road to a porous pavement surface. Address beach encroachment by installing fencing to limit widening of paths and signage to alert beach users to the impact of walking off-trail.

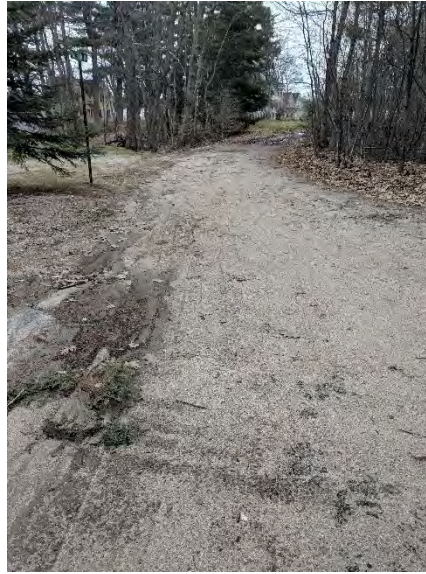
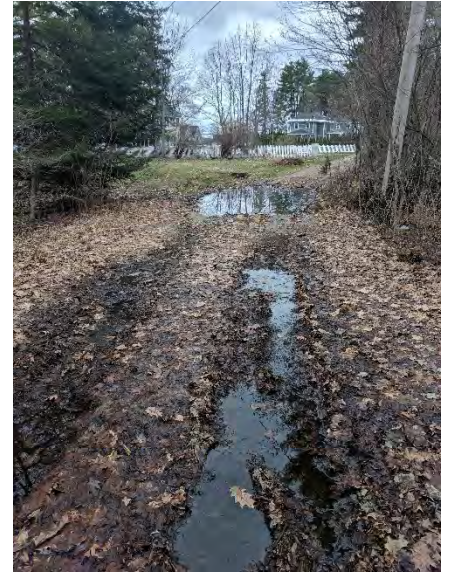
(8) Watchic Road #3 (Site A9)

OBSERVATIONS: Moderate surface erosion on the roadway on Watchic Road #3. The road shoulder has a plow/grader berm. Additionally, the private road off Watchic Road #3 crosses a wetland and has significant ponding and large ruts from vehicle traffic.

(Right) Photos of Watchic Road #3 showing road surface erosion and significant ponding/rutting along the private road.

RECOMMENDATIONS: Re-grade Watchic Road #3 and install runoff diverters to a settling basin. Hire an engineer to assess private road crossing in wetland area.

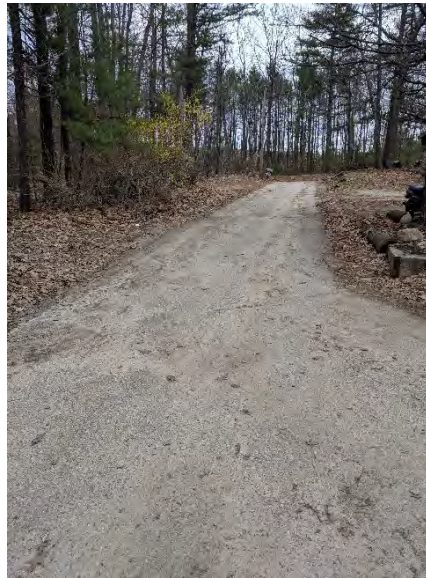
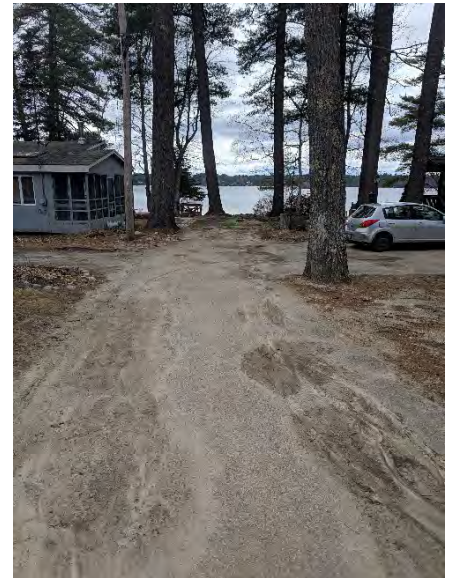
(9) End of Watchic Road #15 (Site A11)

OBSERVATIONS: Significant sediment accumulation and a large grader/blow berm at the end of the road (pictured to the right).

Two photos of Watchic Road #15 showing significant sediment accumulation and the proximity of the end of the road to Watchic Lake.

RECOMMENDATIONS: Install a waterbar (or similar structure) to intercept runoff and direct water to a rain garden. Additionally, improve vegetated buffer between the end of the road and the lake to increase filtering capacity.

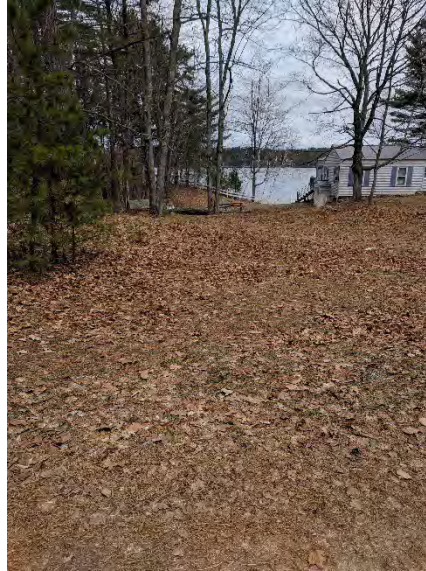
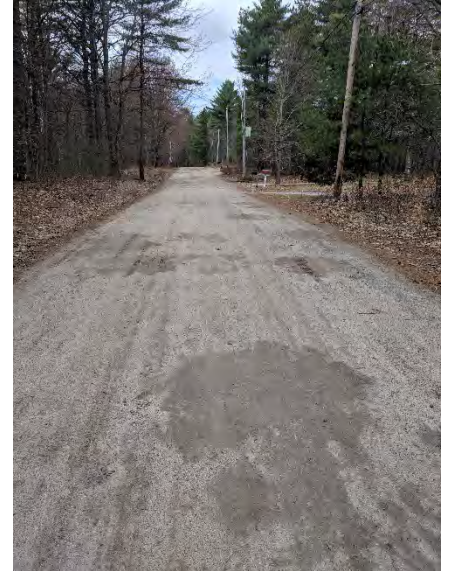
(10) Eleanor Drive (Site A8)

OBSERVATIONS: A local resident alerted us to runoff concerns on Eleanor Drive. A low point in the road is receiving significant runoff during storm events and water is running across a residential lawn directly into Watchic Lake.

(Left) Residential lawn receiving heavy runoff during storm events, (Right) Eleanor Drive road area contributing runoff to the residential lawn.

RECOMMENDATIONS: We recommend the installation of a thin buffer along the residential property to intercept runoff. Eleanor Drive is paved until this section; continuing pavement will help with sediment loads; however, runoff will still occur.
